INDOOR AIR QUALITY ASSESSMENT

**Blackstone Town Hall
15 St. Paul Street
Blackstone, Massachusetts**

Prepared by:
Massachusetts Department of Public Health
Bureau of Environmental Health Assessment
Emergency Response/Indoor Air Quality Program
May 2003

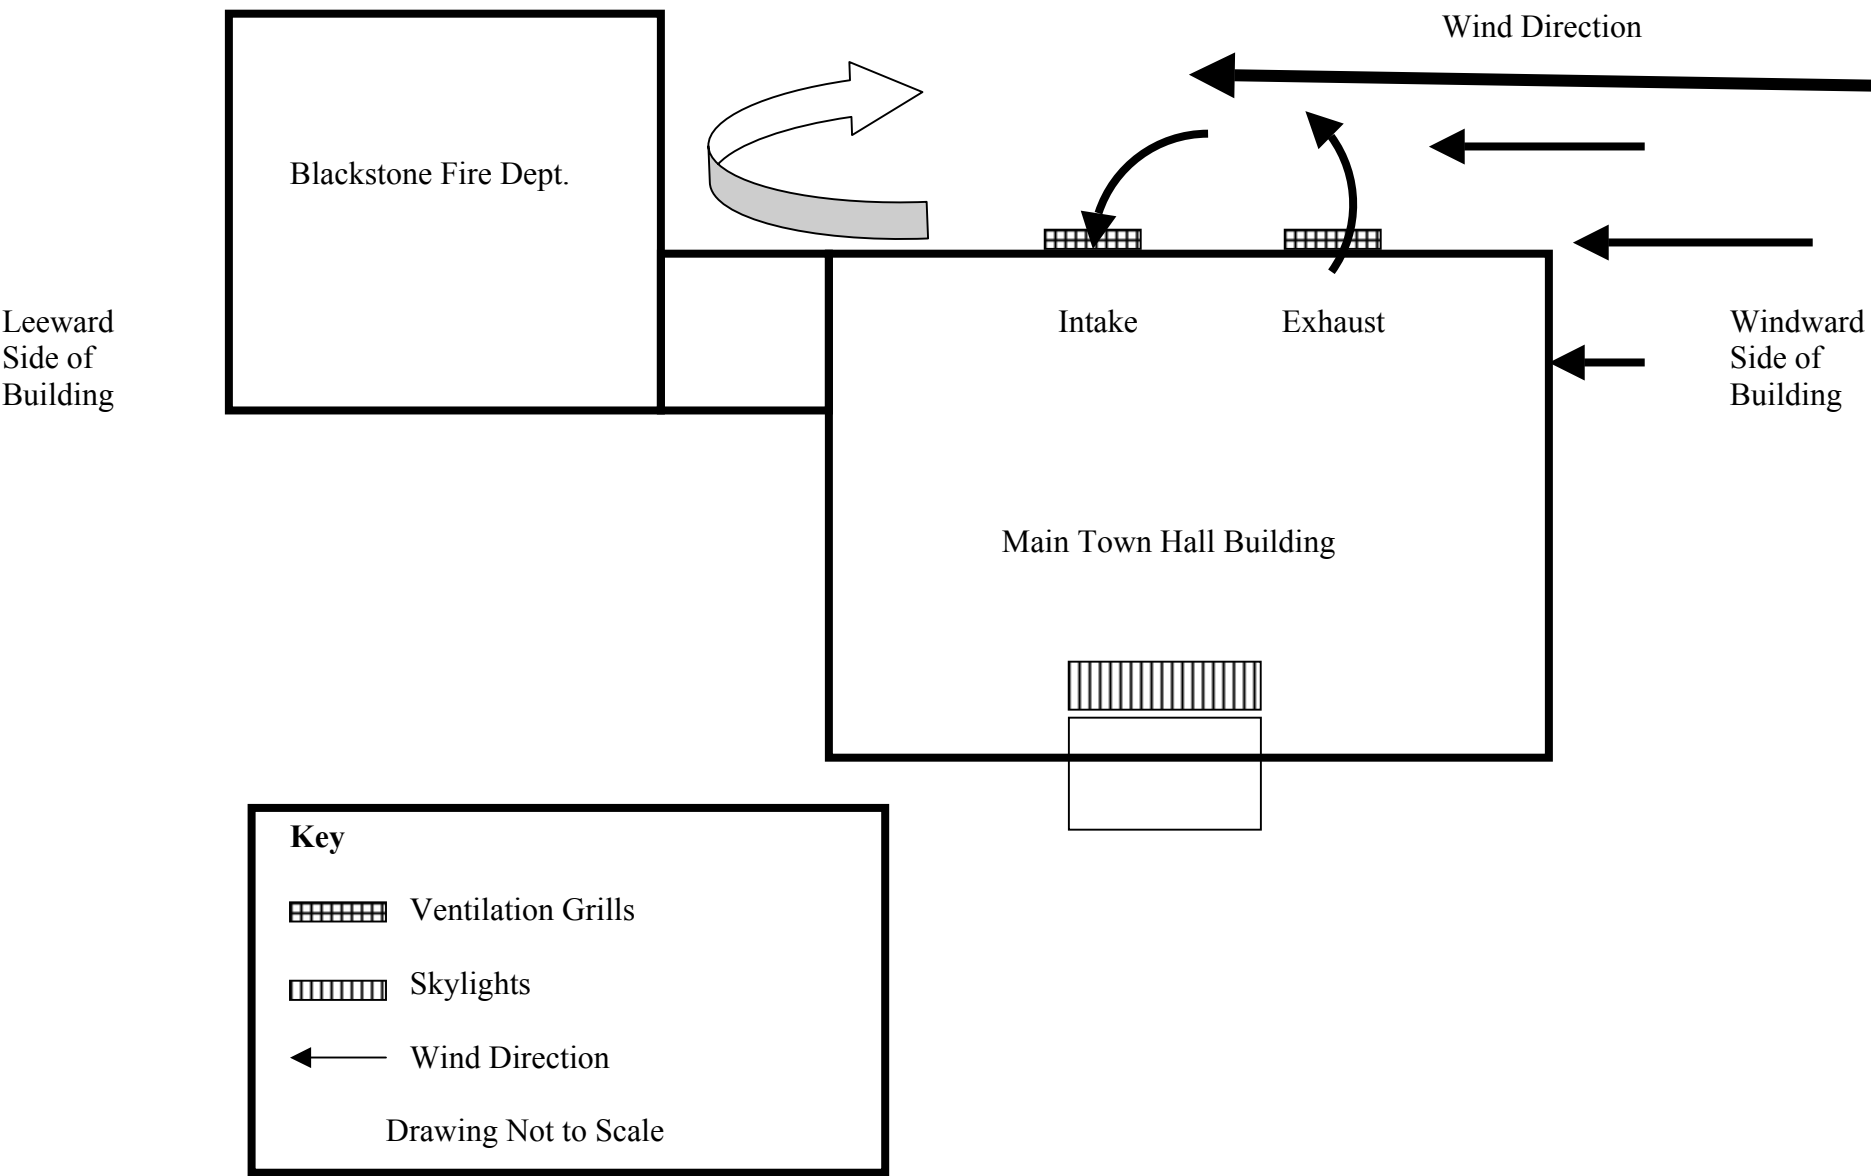
Figure 1

Several other conditions, which can affect indoor air quality, were noted during the assessment. Building occupants report periodic odors of fuel exhaust in the BTH. The design of the building and its location related to the parking lot (see Figure 1/Picture 1) make it possible for vehicle exhaust emissions to be entrained by the AHU. Certain wind and weather conditions can foster the entrainment of these exhaust emissions into the building through the AHU. The process of combustion produces a number of pollutants, depending on the composition of the material. In general, common combustion emissions can include carbon monoxide, carbon dioxide, water vapor and smoke. Of these materials, carbon monoxide can produce immediate, acute health effects upon exposure. Measurable levels of carbon monoxide slightly above background were detected in the building (see Table 1).
